LKWA Water Quality Report

July 2018

Water Quality – 2017 in Review

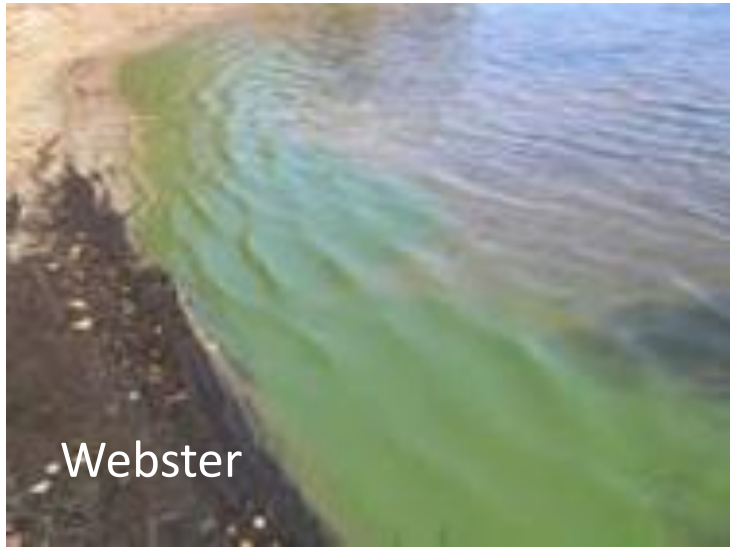
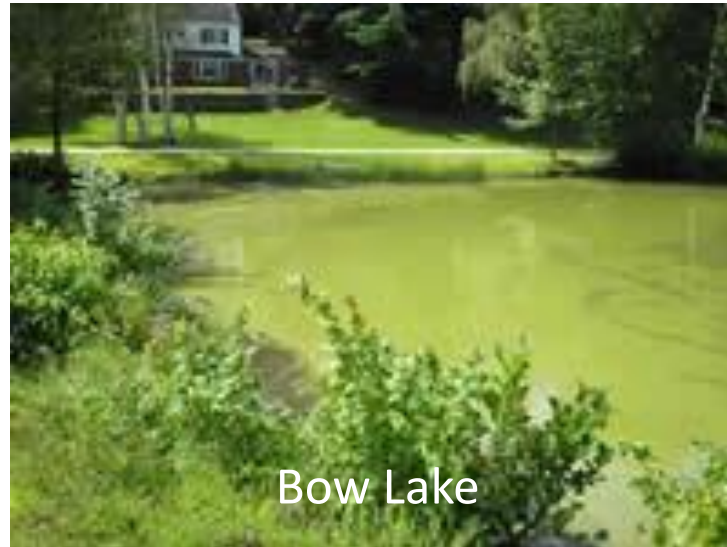
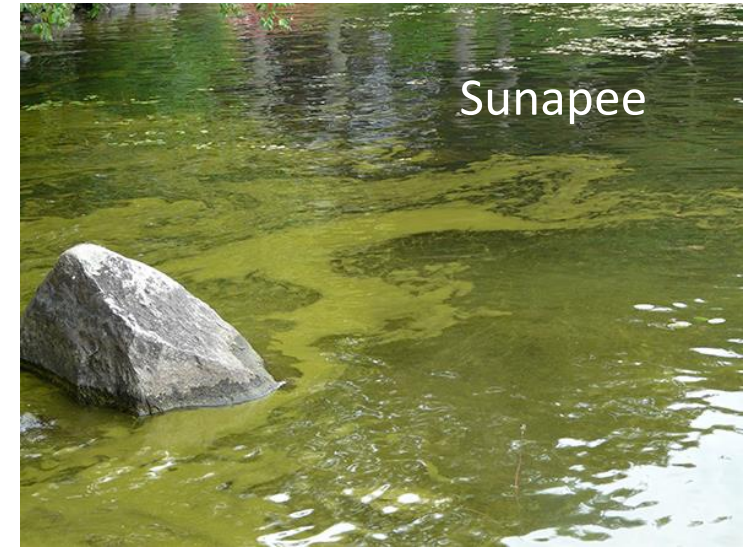
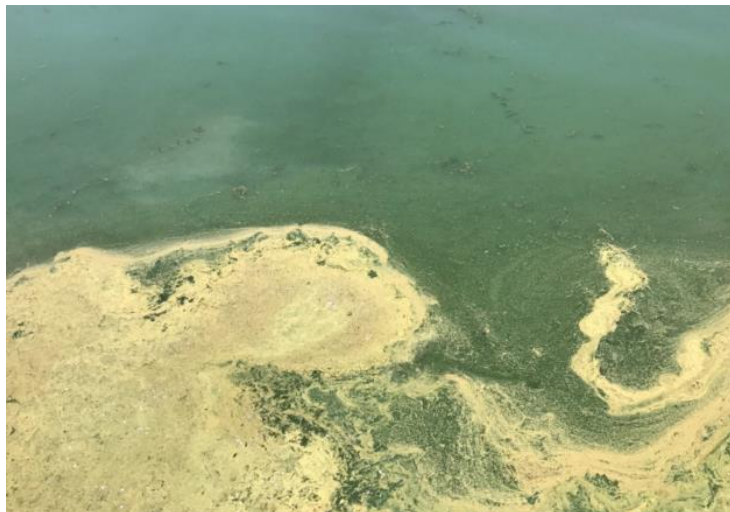
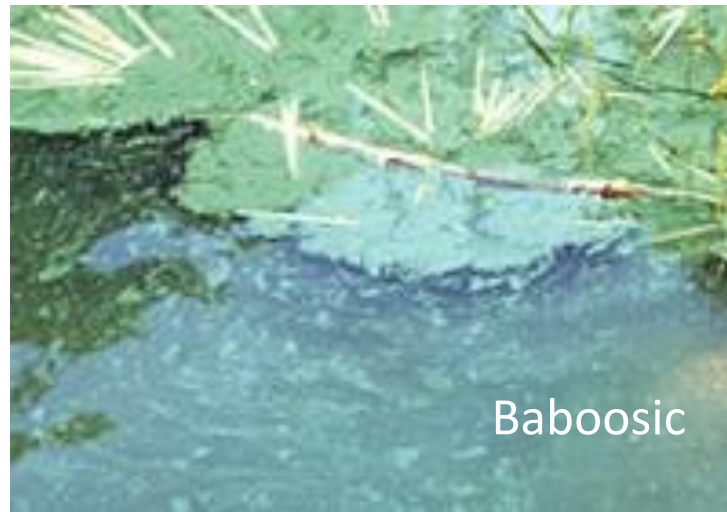
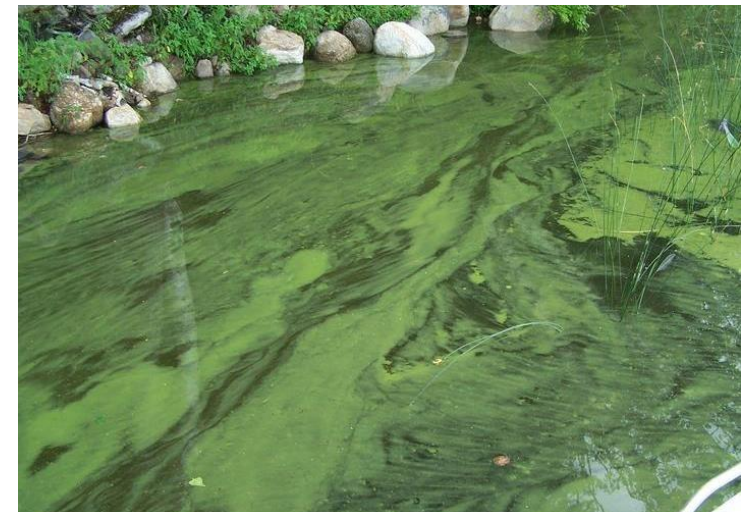
What does an algae bloom look like?
